# Air Force Atlas Mishap Due to Unintended Mixing of LOX and Hydrocarbons 1975

**Leadership ViTS Meeting August 7, 2006**

**Bryan O'Connor Chief, Safety and Mission Assurance**

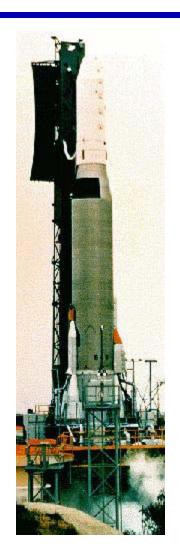
- On April 12, 1975 an Atlas
   71F vehicle suffered
   extensive engine damage
   due to an explosion at liftoff
   at Vandenberg AFB
- Range Safety destroyed vehicle at 303 seconds

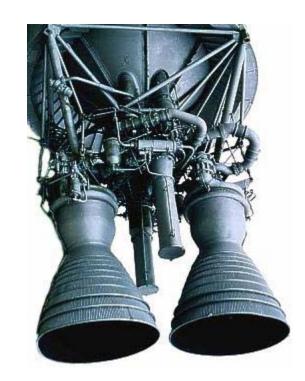
- During the pre-launch sequence, booster engine fuel (RP-1) and GOX/LOX overflows drained into the flame deflector.
- During ignition, additional GOX and LOX were discharged into the flame deflector.
- No water spray or GN2 purge of thrust section occurred prior to the ignition sequence
- An explosion in the flame deflector occurred prior to liftoff.

- Fuel and oxidizer bleeds no longer drained into flame deflector.
- Flame deflector wash-down water system and other water injectors installed to prevent accumulation of combustibles.
- Flame deflector surface re-coated to eliminate eroded condition and prevent pooling of combustibles.
- GN2 purge system installed in booster engine compartment, providing inert atmosphere at liftoff.
- Delay in operation of the pad deluge system eliminated by priming water pipes prior to launch.
